# PORTHCAWL GRAND PAVILION: HERITAGE IMPACT ASSESSMENT CONTENTS

This Heritage Impact Assessment has been prepared by Purcell on behalf of the Awen Cultural Trust and Bridgend County Borough Council as part of their extensive project to refurbish and revitalise the Grand Pavilion. The building is of special architectural and historic interest, becoming Grade II Listed in 1998. The listing report is reproduced in Appendix A. The purpose of this report is to provide a Heritage Impact Assessment for the proposed scheme to refurbish the Grand Pavilion. It has been written to accompany the application for Listed Building Consent.

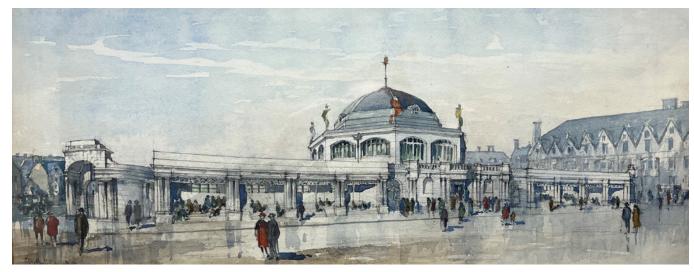
Watercolour image of the proposed design by the Architect, E J Moore, 1931

The original design for the dome was to be considerably higher, as shown on the watercolour image below, with higher clerestory windows below. As built, as shown in the photographs over leaf, the dome is shallower and lower in profile. It has four circular lunette windows, one in each direction. The watercolour shows flag poles at four corners of the octagonal dome, a weathervane and lightning conductor at its apex. The design also shows projecting ribs to each segment of the domed roof, which was covered in asphalt. A late alteration to the design was the flatroofed rectangular addition at the rear, housing the stage and fly tower. The roofs around the dome and over the flanking wings are flat.
